Industry: Plating

Application: Part Washing

Product Descriptions: 1/4" NF10-90

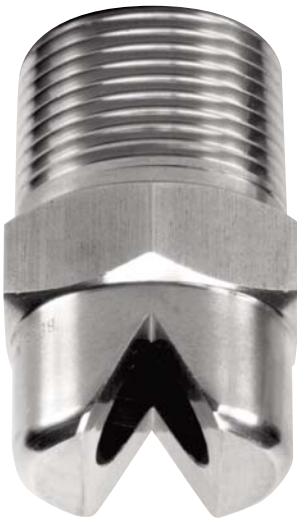
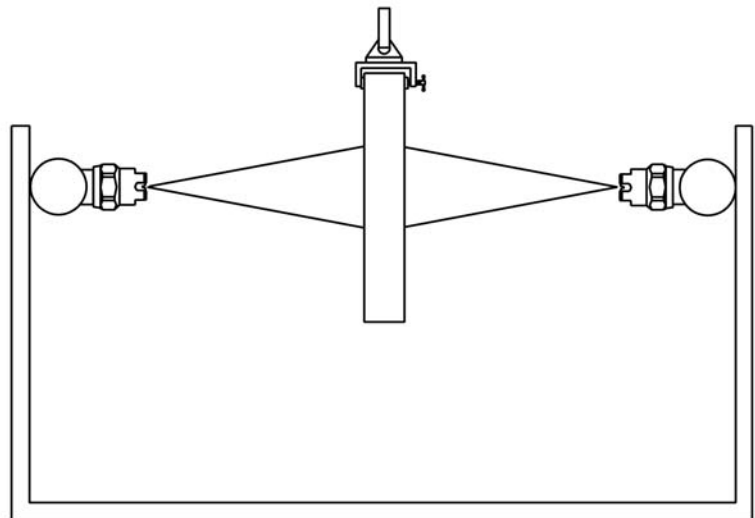
BETE's solution: BETE Application Engineers recommended the standing fluid be replaced with two headers with NF fan nozzles mounted on them. The headers created a horizontal water wall much like the surface of the standing fluid. As the parts were lowered through this water wall they would be rinsed. The cross-contamination from different processes is eliminated because there is no longer any standing fluid.

Situation: A plating company was having trouble with cross-over contamination in their rinsing bath since they use the same rinsing/washing bath for several different plating processes. The current rinsing bath is a large rectangular tub with standing fluid that the parts are lowered into.
