Case Study

SOLVING CLOGGING FROM
SEEDS & SKINS

TOMATO PROCESSING TANK WASHING SOLUTION

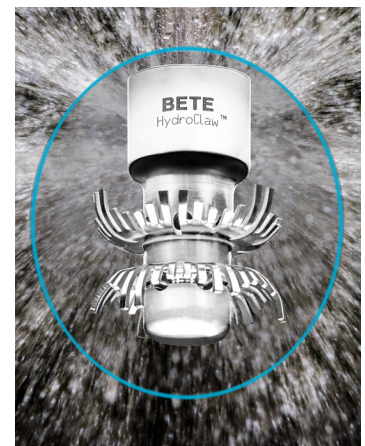
The systems designer had done their research and wanted more information as to whether the innovative HydroClaw[®] was the right solution for their tank washing requirements. After assessing the dimensions of their vessels, BETE engineers recommended six HydroClaw[®] 100 nozzles, three for each tank. The ¼" free passage makes them an ideal solution for flushing through tomato seeds and skins with the recirculated water. The low-maintenance HydroClaw[®] self-flushes as it cleans tanks without any rotating parts or gears to jam up.

The HydroClaw® was explicitly designed to offer a tank washing innovation for wineries – allowing grape seeds and skins to pass through the nozzle. This design feature makes it the perfect nozzle for food processing applications.

- Nozzle designed to let particulates and sediment flow through with no clogging
- Clog resistance and low maintenance = reduced downtime and more economical water usage
- 316L stainless steel construction means it is perfect for clean-in-place (CIP) and food grade applications
- Complete 360-degree coverage
