Industry: Food Processing

Application: Tank Washing

Product Descriptions: Special TW Lance with Sanitary Fittings

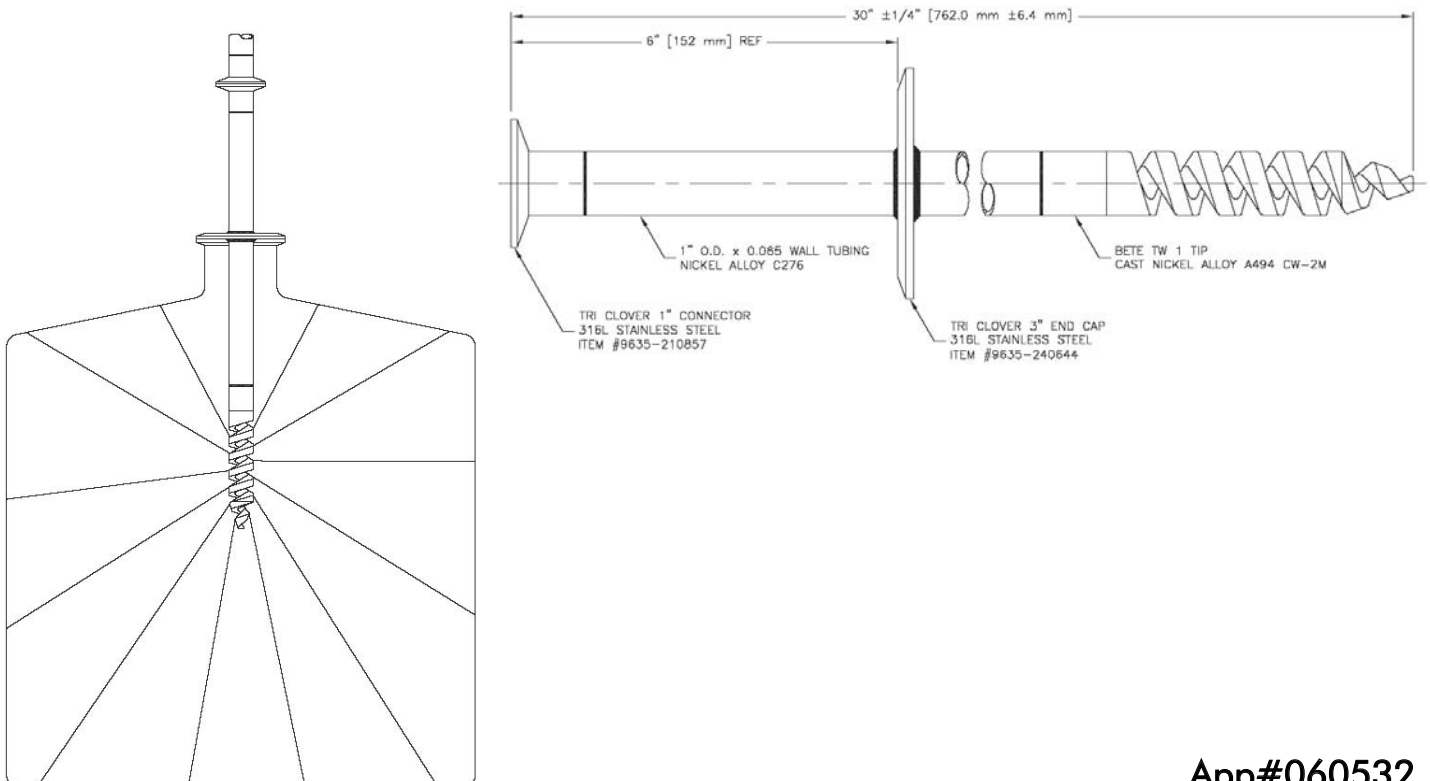
BETE's solution: Because this application required a corrosion-resistant material, BETE Applications Engineers selected nickel alloy C as the material of choice to stand up to the highly acidic environment in which the nozzles and lances would be submerged. Food processing applications such as these require a smooth lance assembly profile and the BETE TW-1s were machined to special dimensions to have the same outside diameter as the tube.
